Pretty Lake
Aquatic Vegetation Management Plan
2007-2011

February 19, 2007

Prepared for:
Pretty Lake Association
319 W. Jefferson St.
Plymouth, IN 46563

Prepared by:
Aquatic Control, Inc.
PO Box 100
Seymour, Indiana 47274

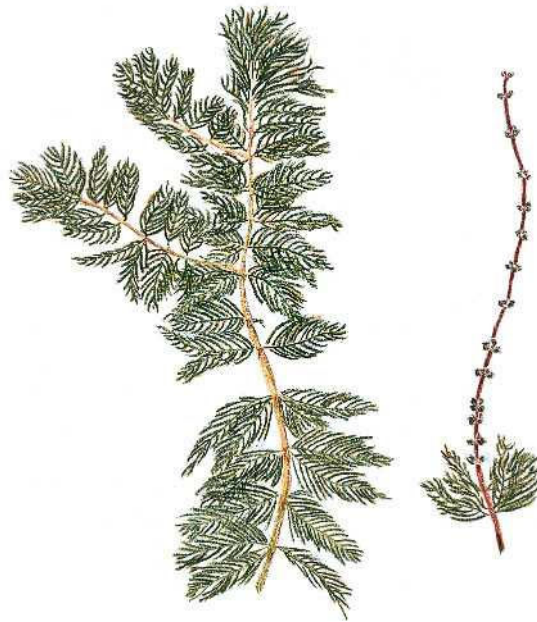
Figure 3. Illustration of Eurasian watermilfoil (Illustration provided by Applied Biochemist).

Eurasian watermilfoil is an exotic invasive species of submersed vegetation that was likely introduced into our region prior to the 1940's (Figure 3). This species commonly reaches nuisance levels in Indiana Lakes. Once established, growth and physiological characteristics of milfoil enable it to form a surface canopy and develop into immense stands of weedy vegetation, outcompeting most submersed species and displacing the native plant community. These surface mats can severely impair many of the functional aspects of waterbodies such as maintenance of water quality for wildlife habitat and public health, navigation, and recreation. Furthermore, a milfoil-dominated community can greatly reduce the biodiversity of an aquatic system and negatively impact fish populations (Getsinger et. al., 1997).

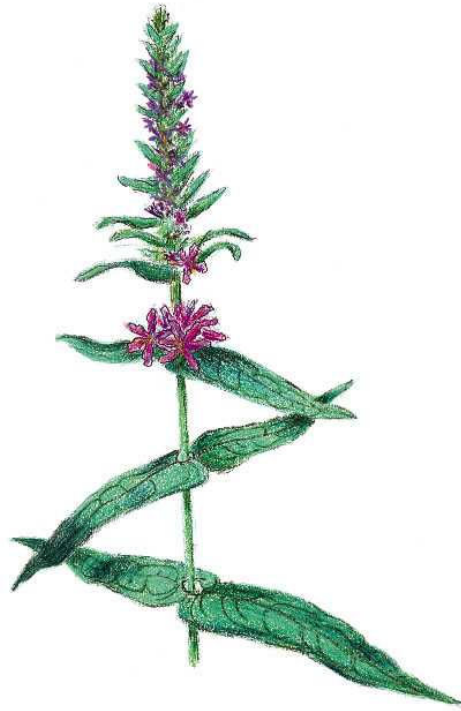
Figure 5. Illustration of Purple Loosestrife (Illustration provided by Applied Biochemist).

Purple loosestrife is an exotic invasive species of emergent vegetation that has invaded many wetlands and lake margins throughout Indiana (Figure 5). This species was introduced from Eurasia and became established in the estuaries of northeastern North America by the early 1800's. The impact of purple loosestrife on native vegetation has been disastrous, with more than 50% of the biomass of some wetland communities displaced. Impacts on wildlife have not been well studied, but indicate serious reduction in waterfowl and aquatic furbearer productivity (Thompson et. al., 1987).

As mentioned when discussing goal number one, purple loosestrife can be detrimental to native wetland species. Control of this species may be funded by LARE depending on availability and prioritization of funds. If this species is discovered on one's property, it will be important to individual homeowners to dig up and remove the entire plant. An illustration of this species was included in Figure 5 located on page 6 of this plan.

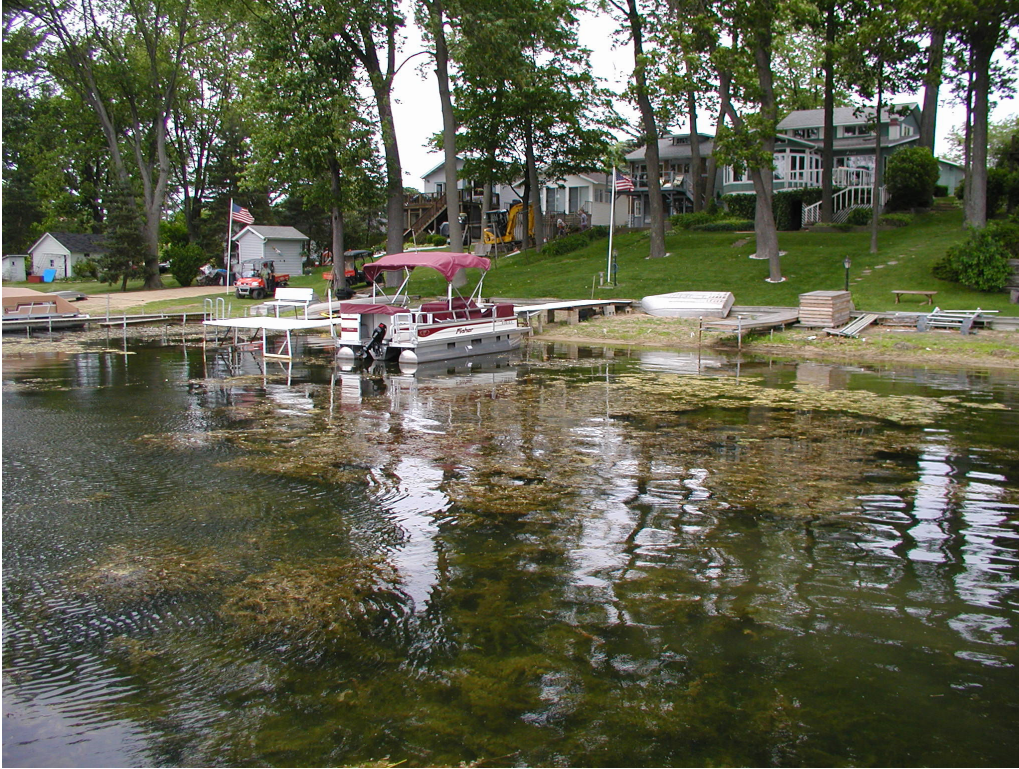
Figure 7. Pretty Lake, nuisance conditions created by Eurasian watermilfoil, June 28, 2006.

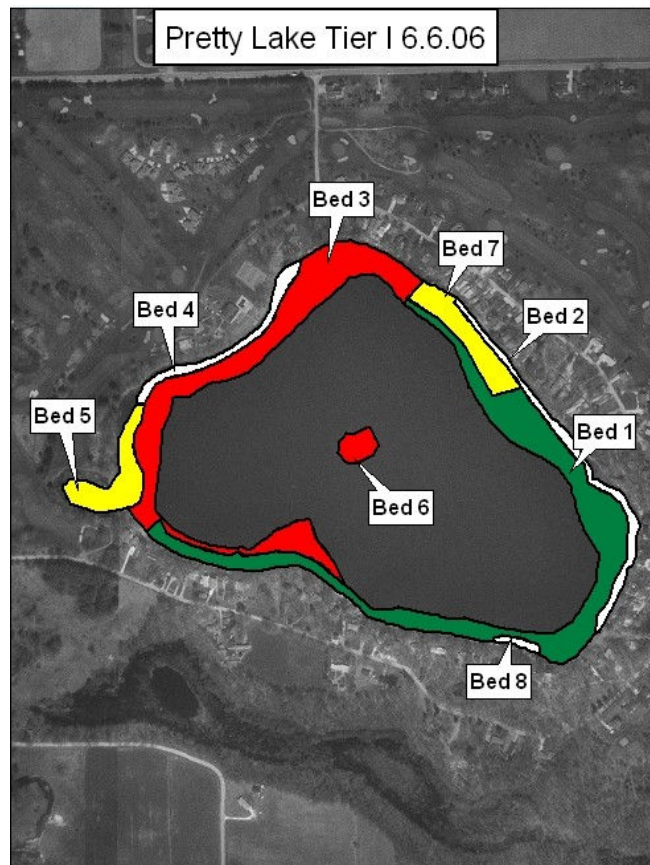
Figure 9. Tier I Plant Beds, Pretty Lake, June 6, 2006

On June 6, 2006, Aquatic Control completed a Tier I survey on Pretty Lake. A Secchi measurement was taken and found to be 14.0 feet. The Tier I survey revealed 8 distinct plant beds within Pretty Lake totaling 30.8 acres. (Table 2 & Figure 9). Vegetation was present to a maximum depth of 23 feet. Seventeen different species were observed.

Eurasian watermilfoil was the most abundant species present during the spring survey. Milfoil had reached the surface in many areas of Pretty Lake and was present in all plant beds with the exception of bed 2. Milfoil was present at an abundance rating of 2 or higher in plant beds 1, 3, 6, and 7. These beds totaled 24.8 acres. Bed 3 was the most impaired by dense milfoil. This bed was located along the shoreline and out several hundred feet along the northwest side of Pretty Lake.

Curlyleaf pondweed was not as dense or abundant as Eurasian watermilfoil. It was observed in only three plant beds. Curlyleaf pondweed received an abundance rating of 2 in beds 1 and 3.

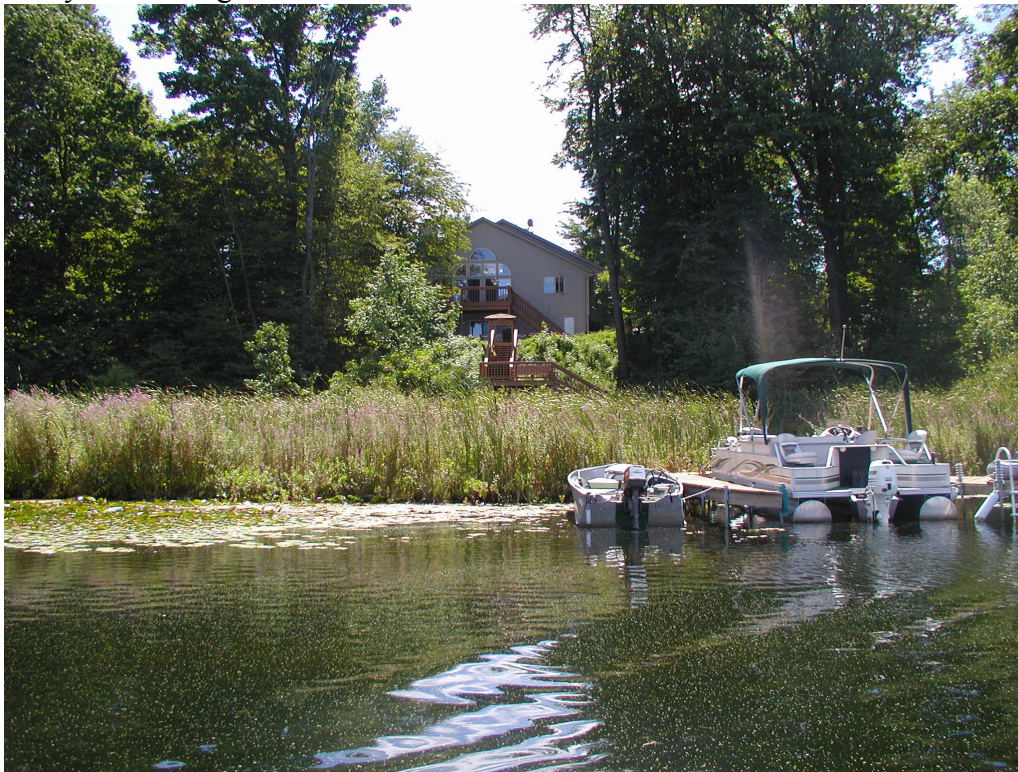
Figure 16. Crooked Lake, emergent plant community along developed shoreline, June 2006.

There is only one large area of rooted floating and emergent vegetation remaining in Pretty Lake. This area is located in the southwest corner of the lake just south of the clubhouse. This community serves several beneficial purposes to Pretty Lake that includes reducing erosion, providing fish and wildlife food and habitat, and filtering excessive nutrients. This plant community should be protected from development. The majority of Pretty Lake's shoreline is developed and much of the shoreline is lined with seawalls. Seawalls are somewhat effective at reducing erosion, but they also eliminate a very ecologically important area of the lakes ecosystem and increase wave action in the lake. New developments should consider natural shorelines that allow emergent and rooted floating vegetation to grow. A dense shallow water plant community should help reduce erosion, prevent geese from entering and exiting the lake, provide cover for fish and wildlife, and help filter nutrients that may enter the lake from developed sites. If erosion is still a problem, glacial stone is the recommended as a replacement for rip-rap or concrete. Figure 16 is an example of a developed shoreline on Crooked Lake in Steuben County. This home site has allowed native vegetation to flourish along their shoreline yet still has good lake access.
